**DEPARTMENT OF TRANSPORTATION****DIVISION OF ENGINEERING SERVICES**

Contract #: 04-0120F4Cty: SF/ALA Rte: 80 PM: 13.2/13.9File #: 69.28**WELDING INSPECTION REPORT****Resident Engineer:**Pursell, Gary**Address:** 333 Burma Road**City:** Oakland, CA 94607**Report No:** WIR-002346**Date Inspected:** 11-May-2008**Project Name:** SAS Superstructure**OSM Arrival Time:** 2300**Prime Contractor:** American Bridge/Fluor Enterprises, a JV**OSM Departure Time:** 730**Contractor:** Zhenhua Port Machinery Company, Ltd (ZPMC), Changxing Island **Location:** Shanghai, China**CWI Name:****CWI Present:****Yes No****Inspected CWI report:** **Yes No N/A****Rod Oven in Use:****Yes No N/A****Electrode to specification:** **Yes No N/A****Weld Procedures Followed:****Yes No N/A****Qualified Welders:** **Yes No N/A****Verified Joint Fit-up:****Yes No N/A****Approved Drawings:** **Yes No N/A****Approved WPS:****Yes No N/A****Delayed / Cancelled:****Yes No N/A****Bridge No:** 34-0006**Component:** OBG**Summary of Items Observed:**

Caltrans Quality Assurance (QA) Inspector, Mike Hasler was present to observe the fitup, welding and related activities associated with the fabricating of Caltrans Mock-up, 77M

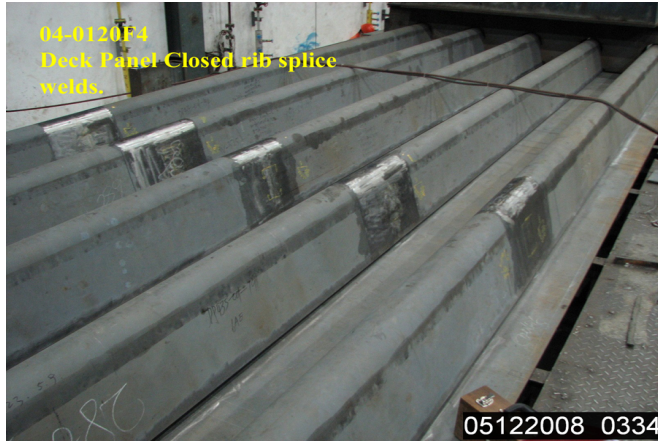
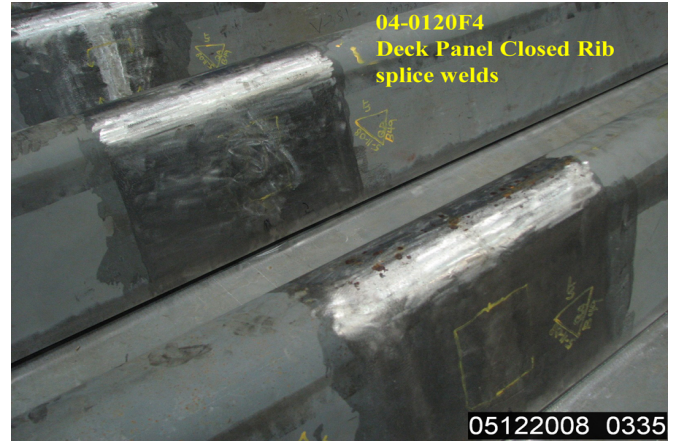
Item	Description	WBS	Dwg No.	Status
1	Closed Rib Deck Panel	NA	NA	QA-UT
<p>OBG Bay 1: Caltrans QA Inspector performed ultrasonic verification testing of u-rib complete joint penetration butt joint splice welds, identified as DP435-001-190, DP435-001-191, DP435-001-192, DP435-001-193 and DP435-001-194. The Ultrasonic Testing (UT) was performed to verify that 10% of the weld meets the requirements of the contract documents and AWS D1.5-2002. The weld and base metal were scanned utilizing a Krautkramer Branson USN 60. Caltrans QA Inspector performed a base metal lamination check using a 25mm diameter 2.25 MHz transducer and a shear wave scan was using a 19mm x 16mm 2.25 MHz transducer on a 70 degree angle wedge from face A. Caltrans QA Inspector utilized Scanning patterns A, B, C, and E. Caltrans QA Inspector found the welds inspected to be in compliance with AWS D1.5- 2002 Table 6.3 and the contract documents. See Caltrans Ultrasonic Testing Report (TL-6027), dated May 11, 2008 for additional information. The following digital pictures illustrate closed rib splice welds.</p>
